MISCELLANEOUS PAPER GL-86-21

STRUCTURAL ENHANCEMENT OF RAILROAD TRACK STRUCTURES USING ASPHALT UNDERLAYMENT

David M. Coleman

Geotechnical Laboratory

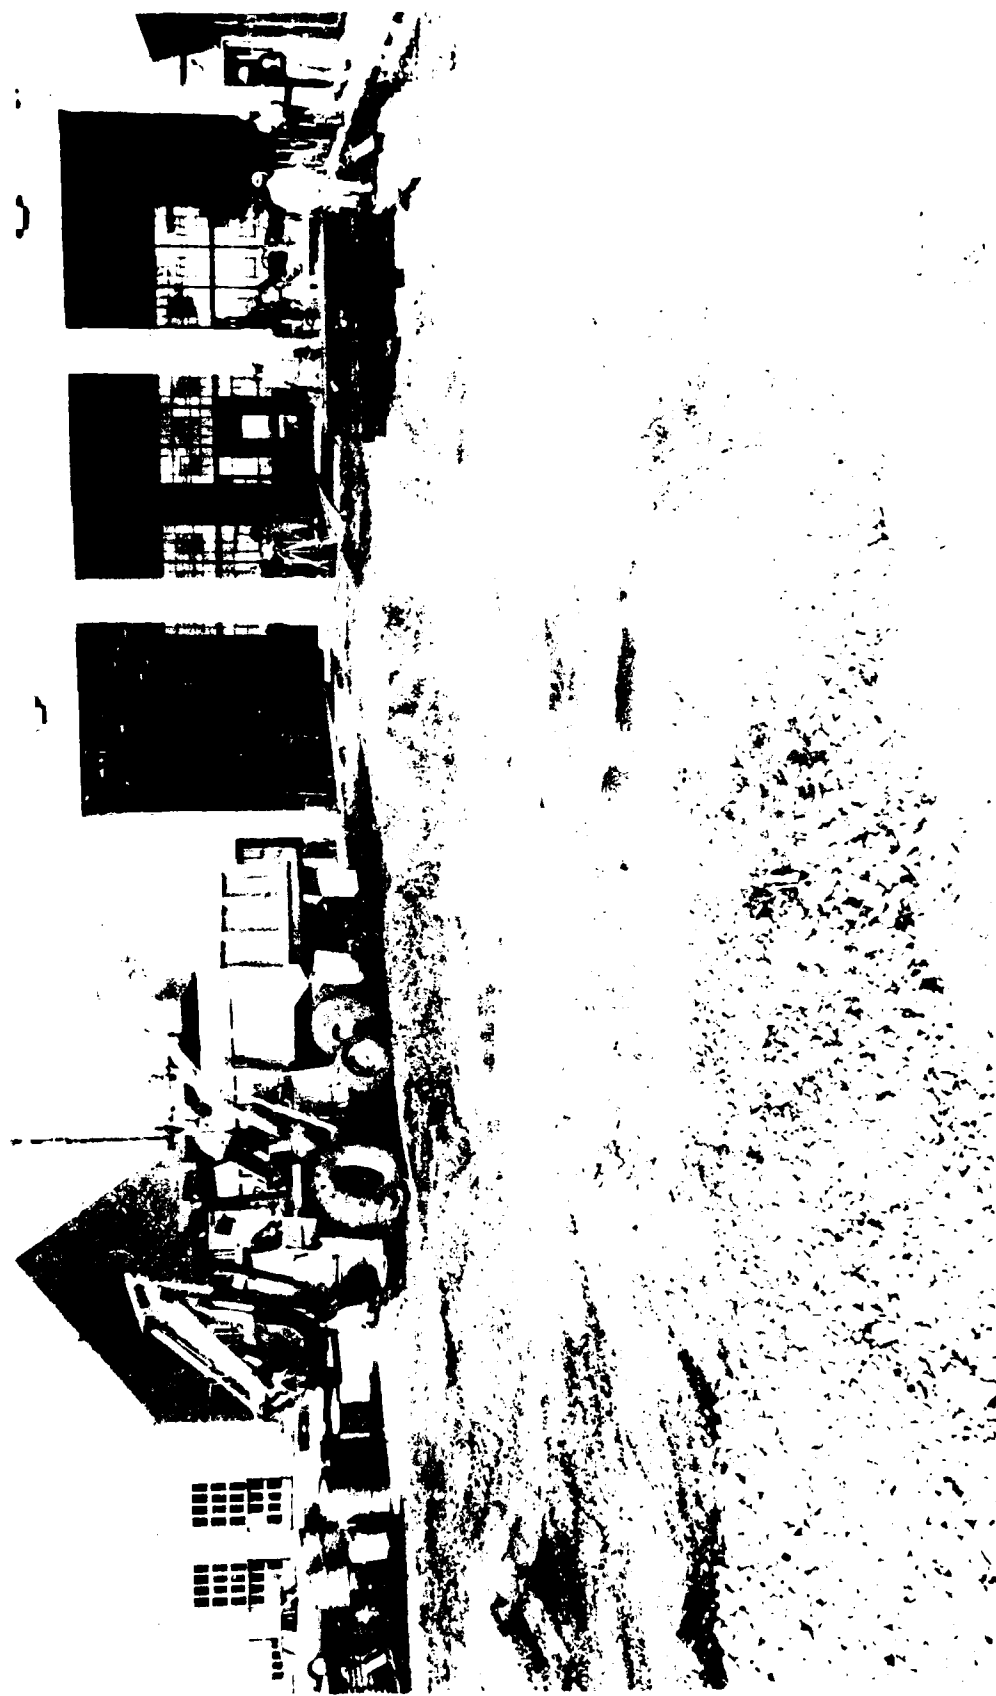
Figure 16. Removing old ballast, sta 6+00

22. Once all the track materials had been removed the contractor began removing the ballast. The ballast was removed using a bulldozer, endloader, and dump trucks. Figures 16 and 17 are typical of the ballast removal process. As the ballast was removed, a layer of water was found to be present between the ballast and subgrade. This water covered the entire area between sta 0+95 and 3+00 and was apparently surface water that had drained through the ballast only to become trapped on top of the subgrade. This trapping of the water was most likely due to the impermeable nature of the clay subgrade and the fact that the natural ground surrounding this area was higher than the roadbed. During the ballast removal numerous soft spots and pumping areas were observed. Figure 18 shows the soft subgrade conditions that existed after all of the ballast was removed.

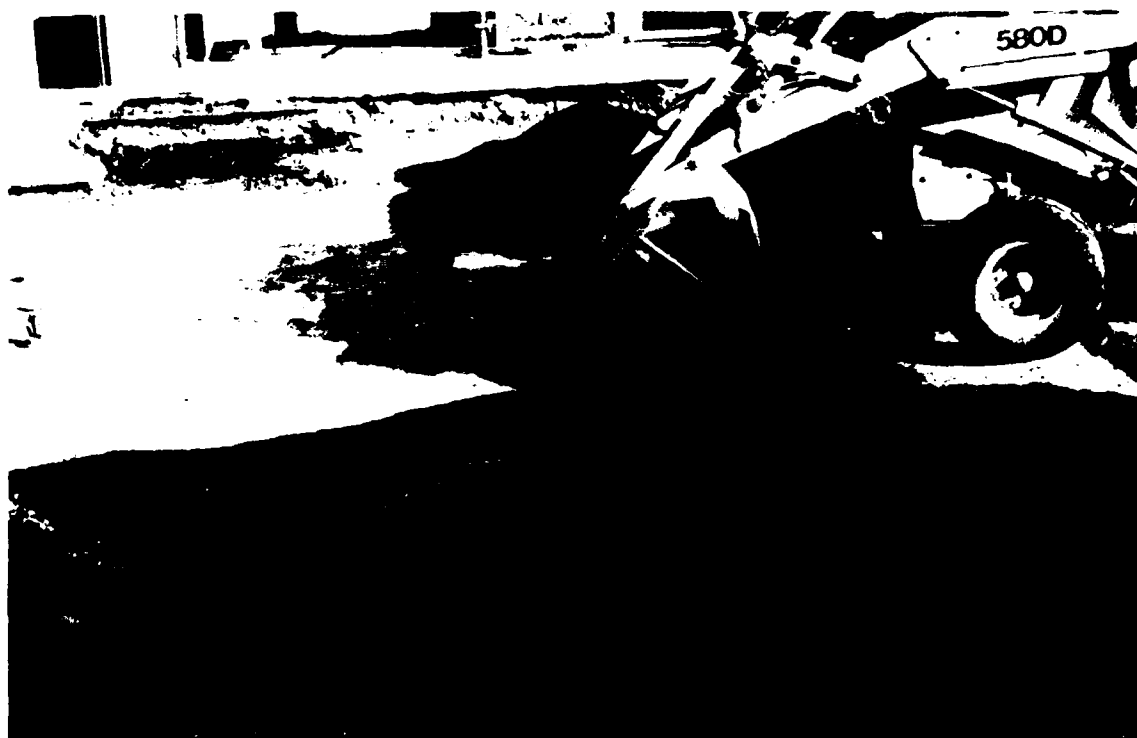
Figure 30. Initial spreading of asphalt in excavated area
between sta 0+95 and 1+15

33. Conventional asphalt paving equipment and procedures were used to place the asphalt underlayment. The first two dump truck loads of hot-mix brought onto the project were placed in the excavated area between sta 0+95 and 1+15. A total of 25.3 tons of mix was dumped in this area and spread with an end loader, shovels, and rakes as seen in Figures 30 and 31. A vibratory plate compactor and a steel wheeled vibratory roller were used to compact this mix. After the hole had been repaired, the placement of the underlayment was begun. A small laydown machine with a maximum laydown width of 12 ft was used to spread the asphalt. Compaction of the mix was accomplished with a Dynapac CCl4 vibratory roller and a small 1-ton roller. The underlayment was placed in two lifts with each lift being approximately 2.25 in. thick uncompacted or approximately 2 in. thick compacted, for a total compacted thickness of 4 in. The first lift began at sta 0+95 and continued to sta 6+25 on Track No. 3. An additional pass was made north of sta 5+00 to place the underlayment under the entire turnout to Track No. 5. The first lift of the underlayment extended back to sta 5+00 on Track No. 5 to include the additional section and a 2-in.-thick transition section. The second lift extended from sta 0+95 to 6+00 on Track No. 3, and back to sta 5+15 on Track No. 5. Figures 32 and 33 present typical scenes of the laydown operation during the

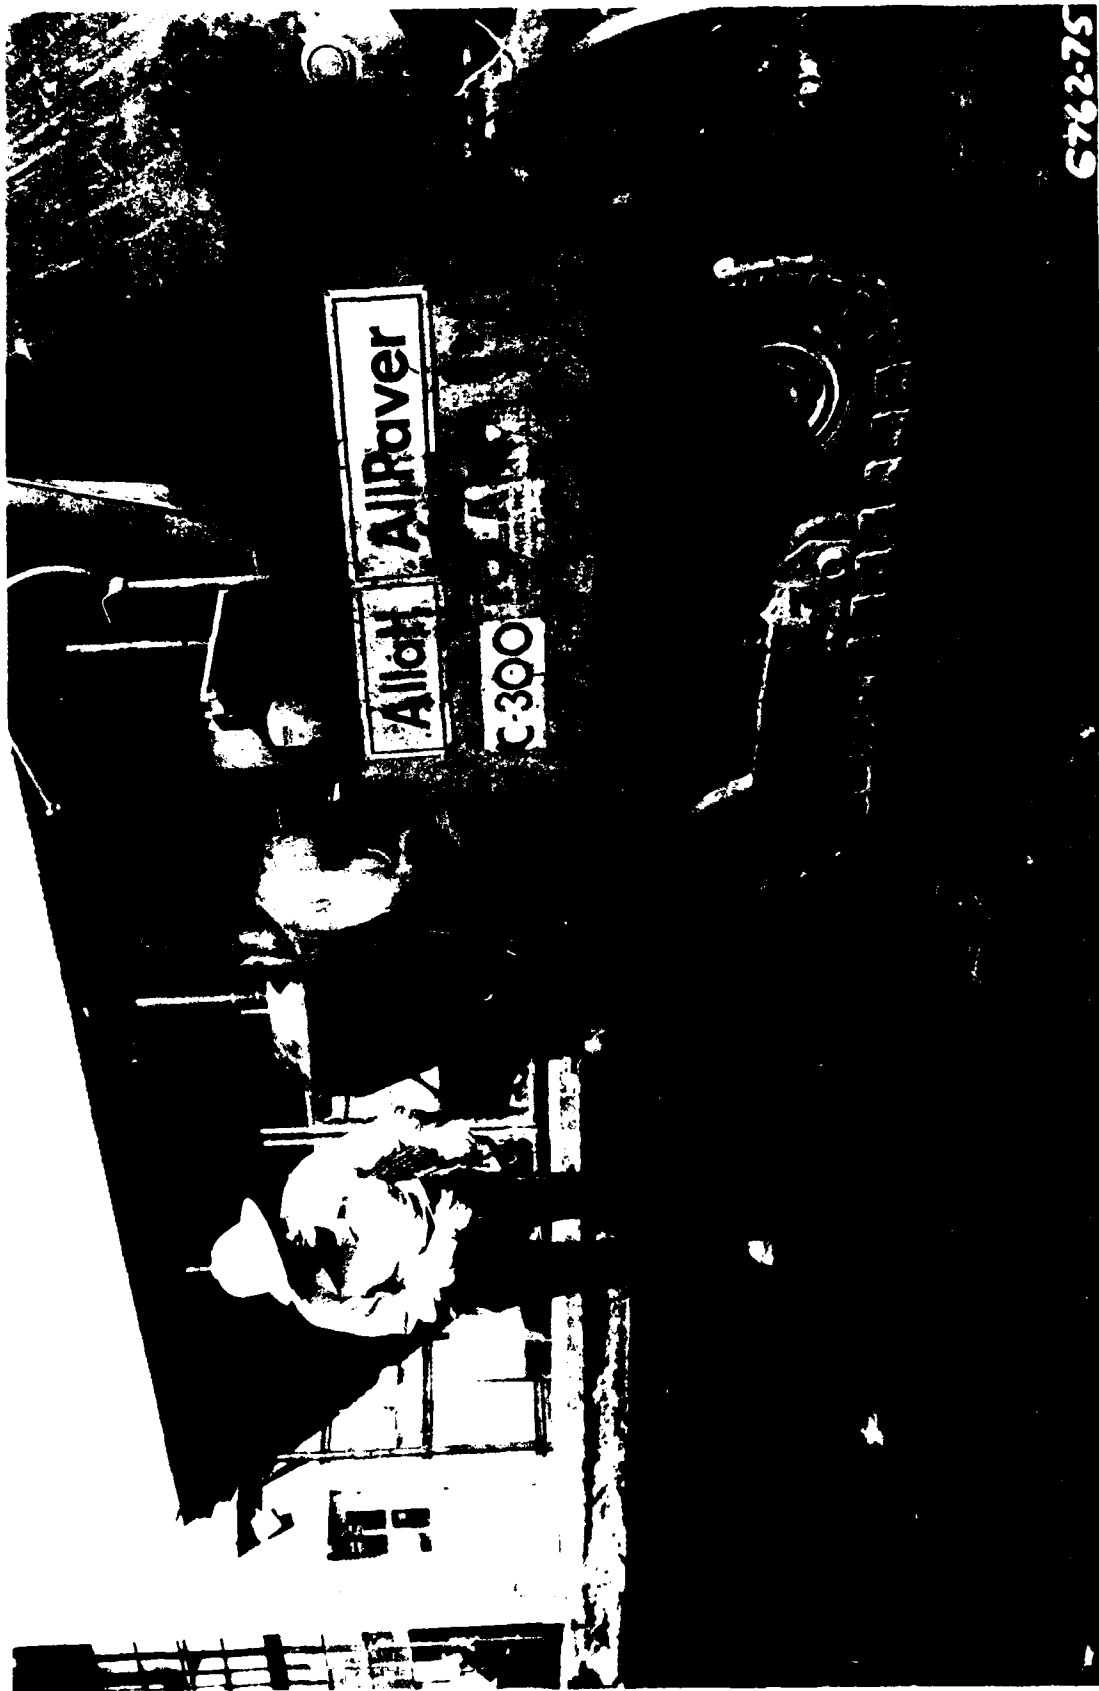
Figure 33. Asphalt laydown, second lift

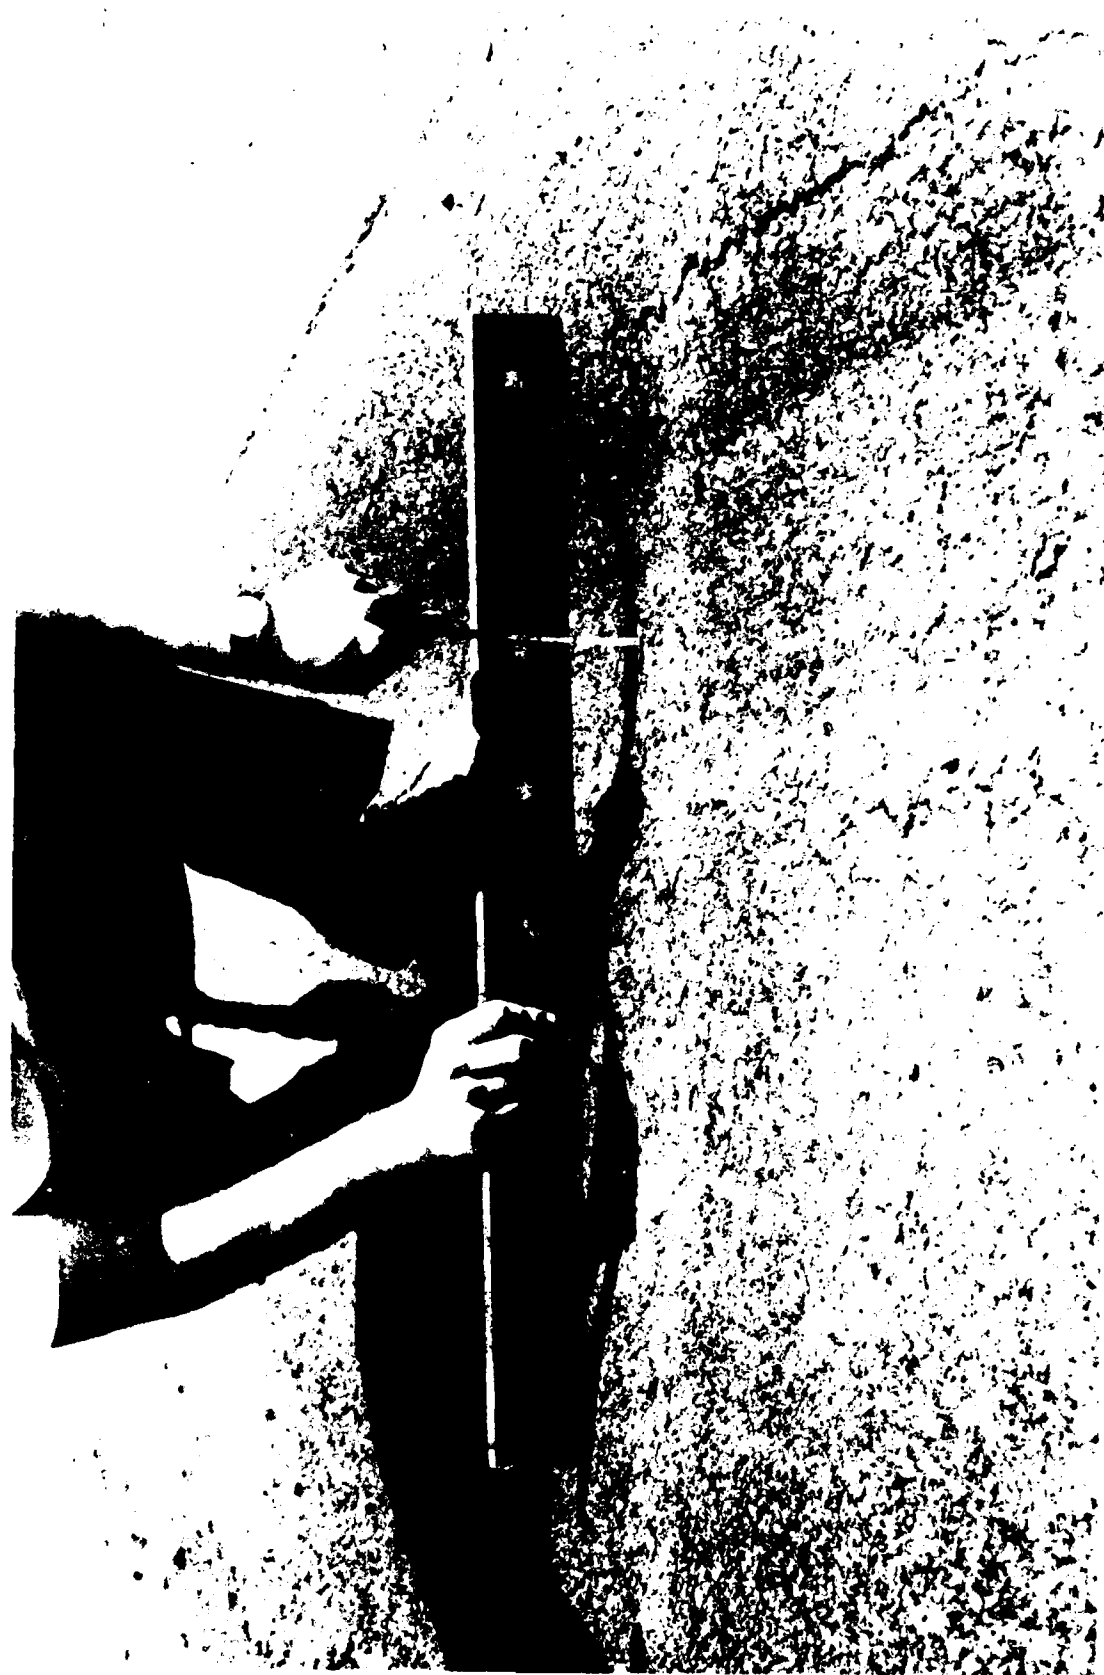
Figure 36. Settling of first lift due to soft subgrade 20 ft right, sta. 2+63

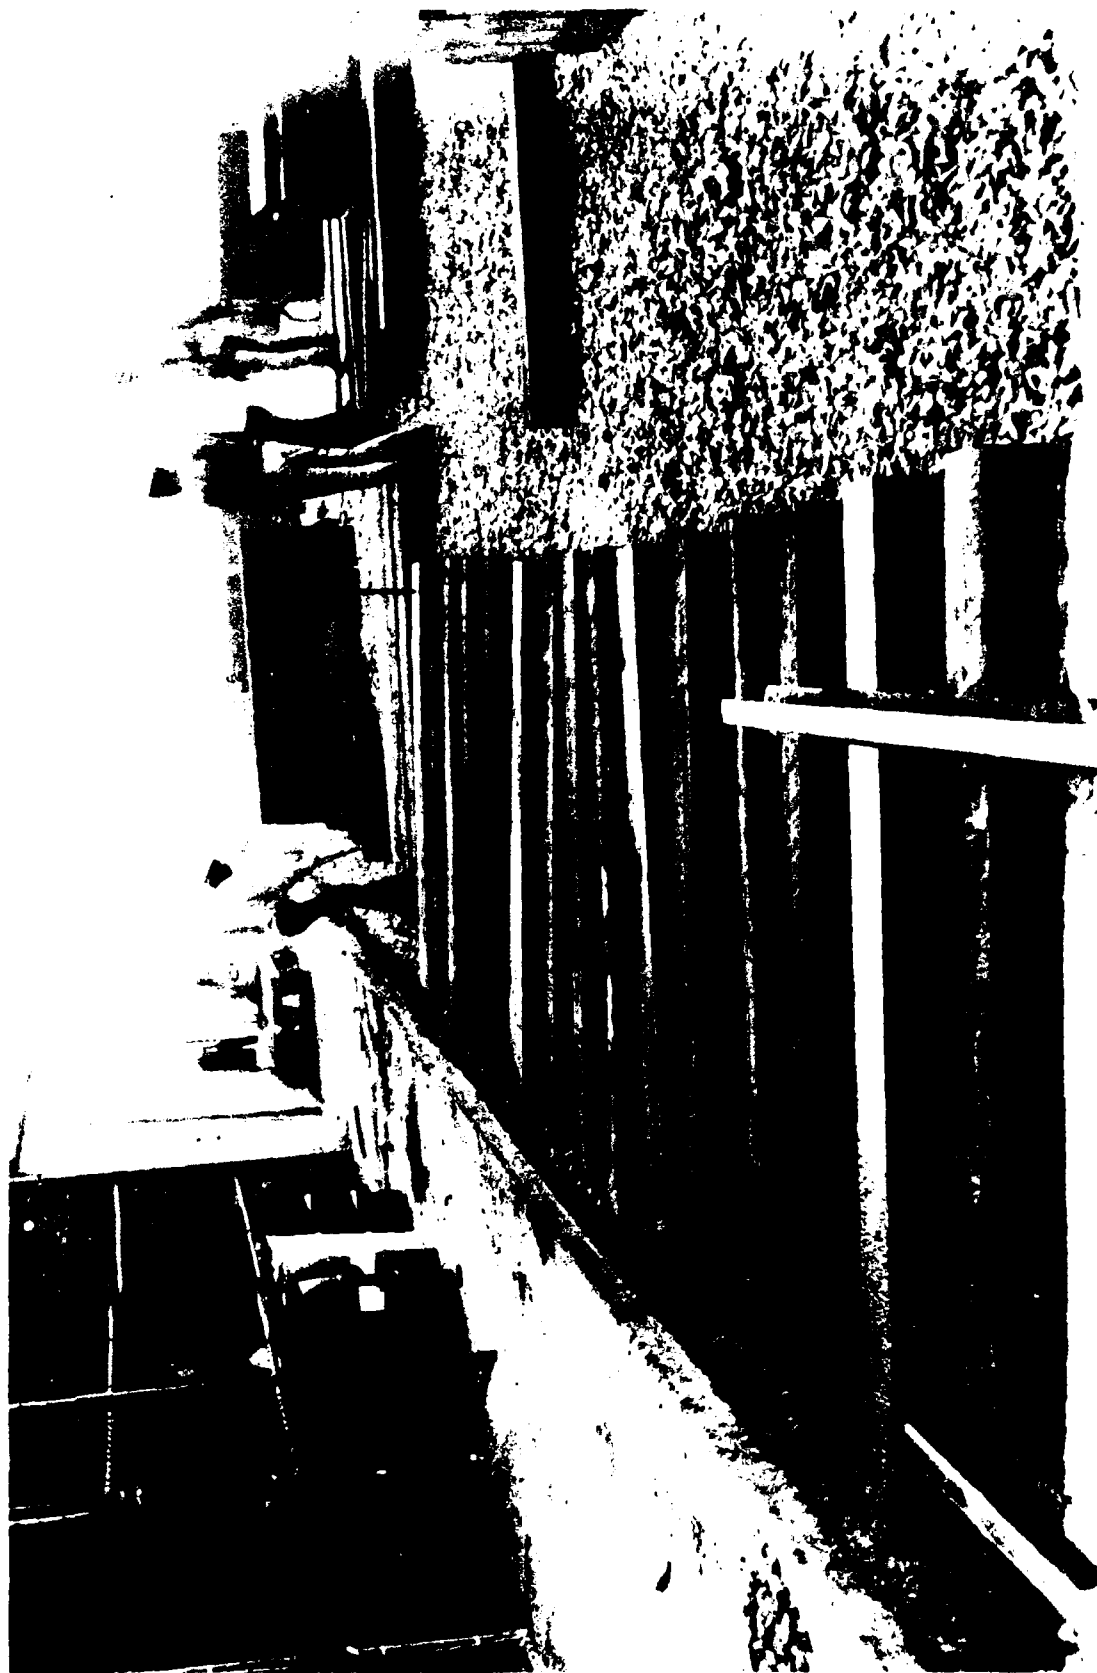
Figure 40. Placing ties

37. After the ballast had been spread, the replacement of the track began. Bundles of new ties were unloaded over the project area, and men with tie tongs moved them into position (Figure 40). Once the ties were in the correct location, tie plates were placed in their proper location on the ties (Figure 41). The rail was then replaced as shown in Figure 42. Each rail had been numbered prior to removal, and the rails were returned to their original location in the track. The joint bars were cleaned and oiled prior to their installation in track (Figure 43). New bolts and washers were used in all joints along with the previously used joint bars. Any defective joint bars found during the installation were replaced prior to installation. The rails were gaged (Figure 44) and spiked every fourth tie to hold them in place until all the rail could be installed and the final spiking completed.

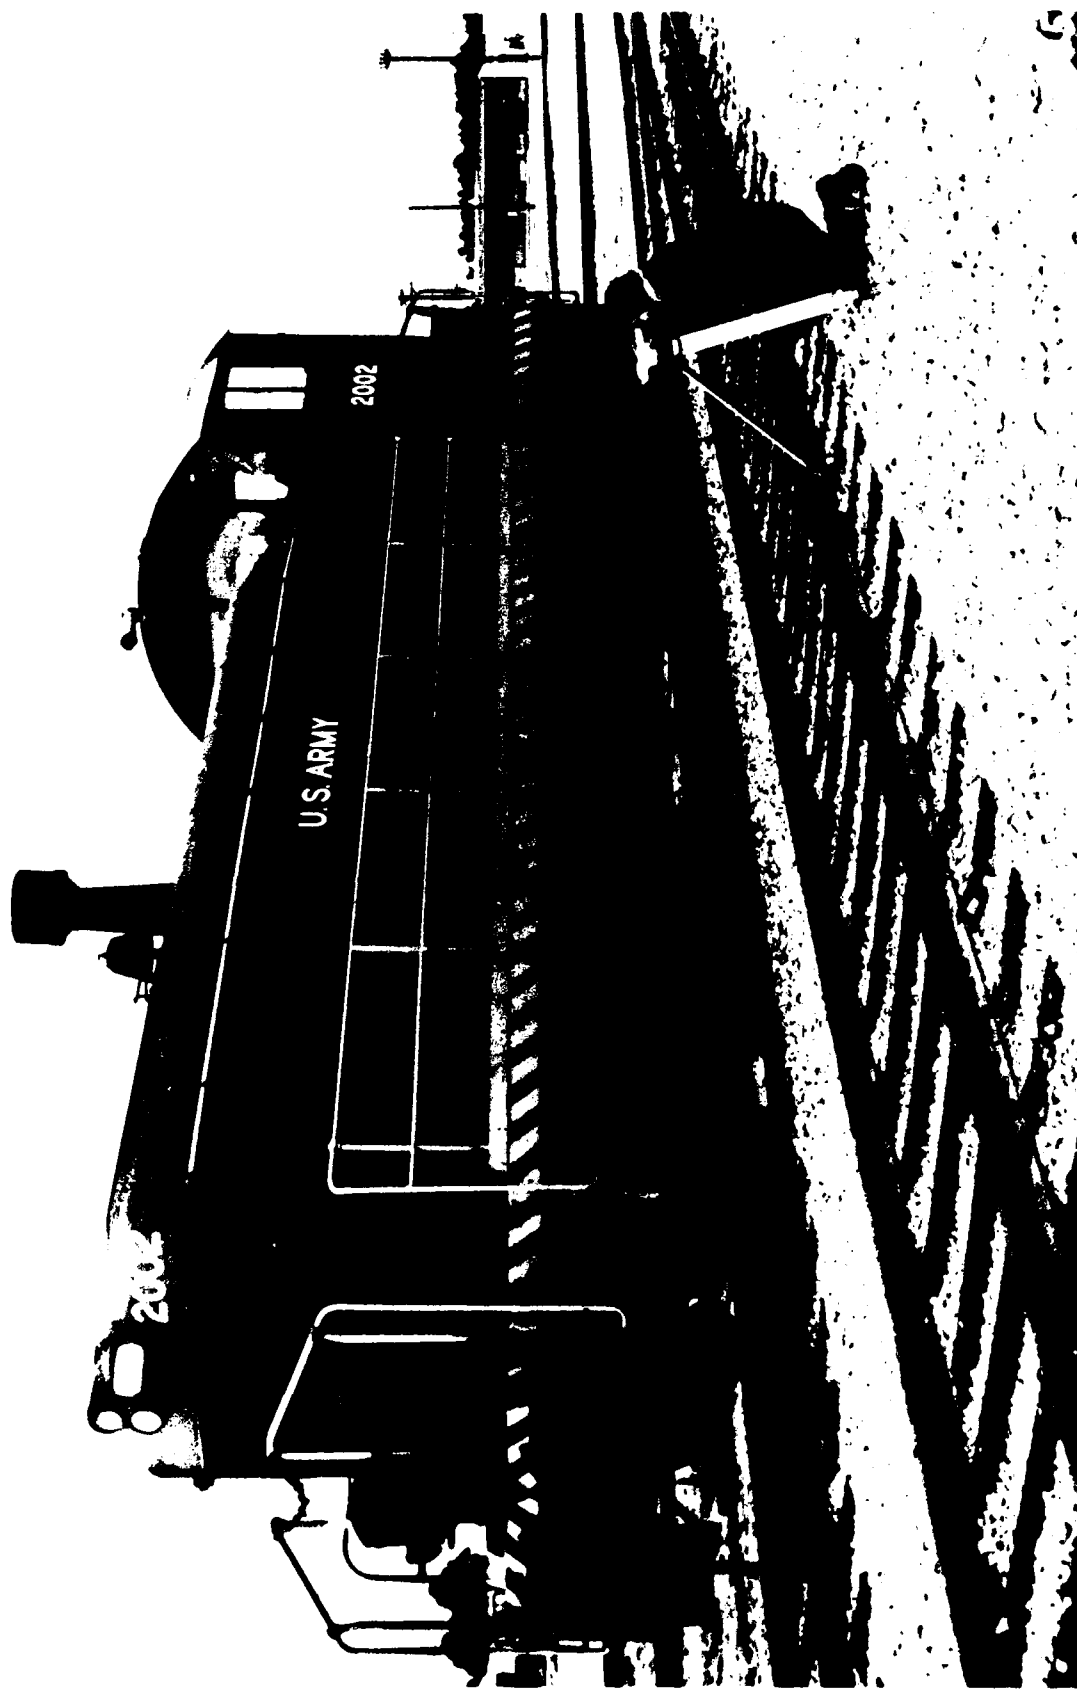
Figure 60. Track deflection test setup

45. Prior to the construction of the demonstration section, auger borings were performed along the center line of Track Nos. 1 and 3, and moisture content samples were obtained. Track deflection tests were performed on the tracks to determine the preconstruction track modulus. Upon the completion of the construction the track deflection tests were repeated in the same locations as the preconstruction tests, and the top of rail profiles on both the north and south rail of each track were obtained. To assist in the future location of the project stationing, stamped metal plates approximately 2 in. by 2 in. were nailed into the ties at 50-ft intervals.
